RESEARCH MEMORANDUM

FACILITIES AND METHODS USED IN FULL-SCALE
AIRPLANE CRASH-FIRE INVESTIGATION

By Dugald O. Black

Lewis Flight Propulsion Laboratory
Cleveland, Ohio

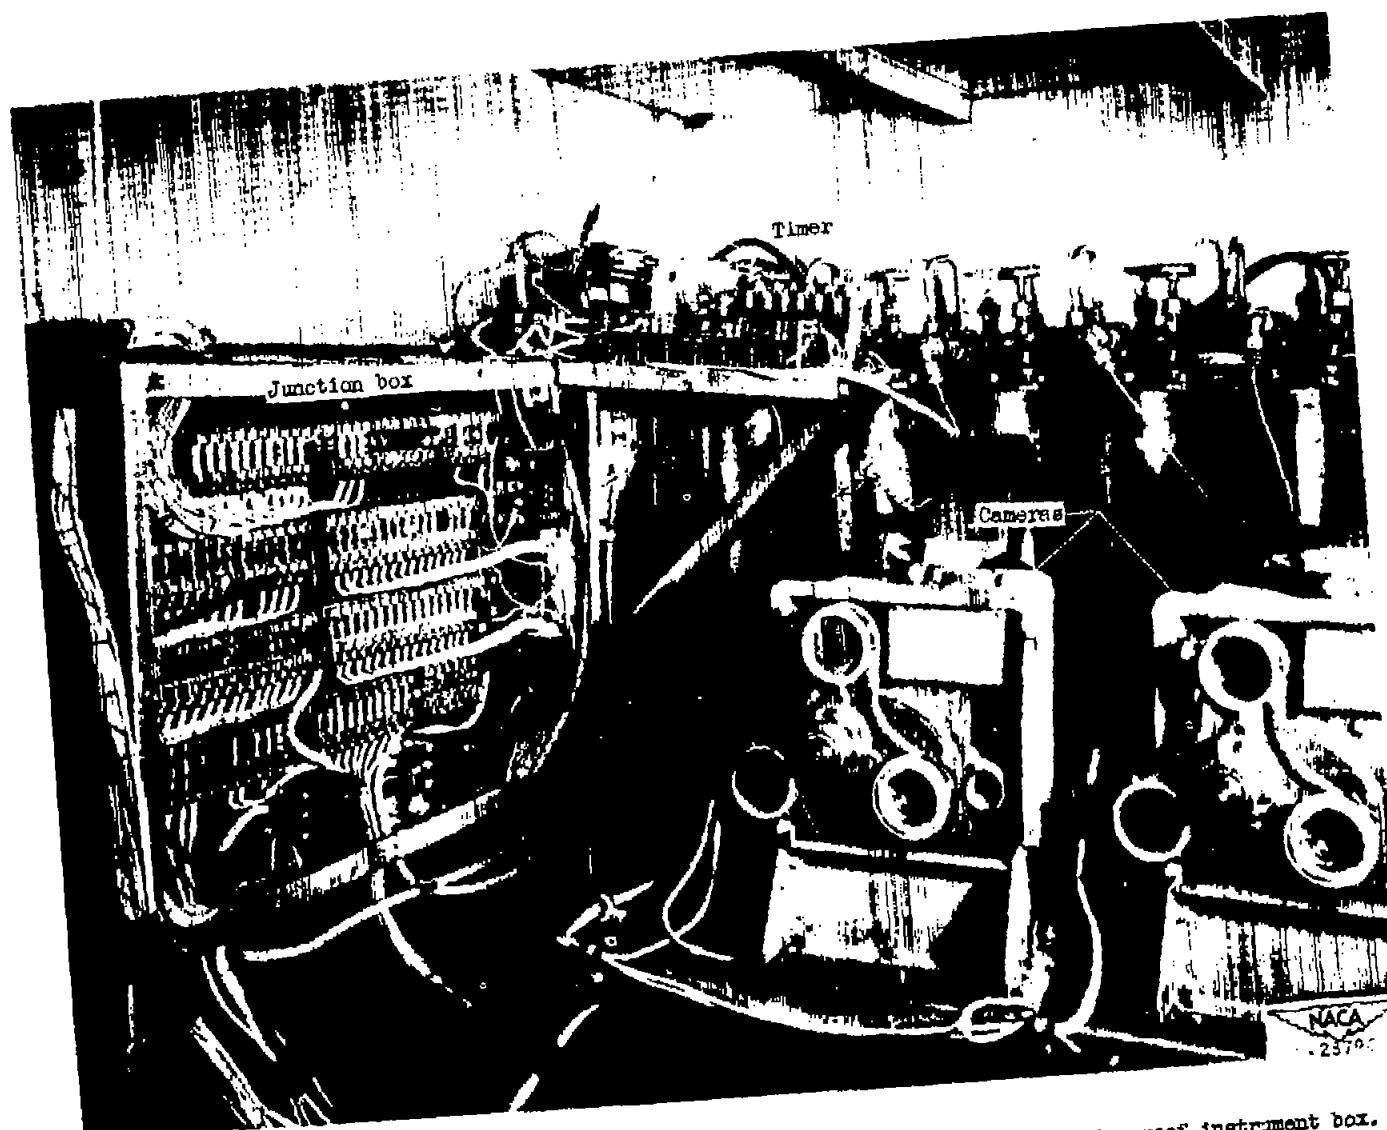
Figure 24. - Closeup view of installation of cameras, junction box, and timer in fireproof instrument box.

Fireproof instrument box. - It was necessary that the temperature inside the instrument box remain below 200° F in order to protect the motion-picture film in the cameras. A sketch of the fireproof instrument box showing the general dimensions and type of construction is presented in figure 20. The inside dimensions were: length, 8 feet; width, 5 feet; and height, 4 feet. The box was constructed of three 1/16-inch-thick black-iron boxes nested together with 3 inches of insulation between the inner and center boxes; 3 inches of water between the center and outer box walls with 1 inch and 5 inches of water on the bottom and the top, respectively. The inner box was shock mounted to the center box by rubber mounts to help absorb the shock of the crash. Figure 21 shows the construction of the instrument box before the top was installed. This view shows the space for insulation, water jacket, and rubber mounts. The instrument panel was mounted at one end of the box as shown in figure 22. Batteries for power, potentiometer, cameras, junction box, cabin-air sampling containers, and timer were located at the opposite end of the box as shown in figure 23; figure 24 is a close-up view showing the installation of the cameras, junction box, and timer for cabin-air sampling system.

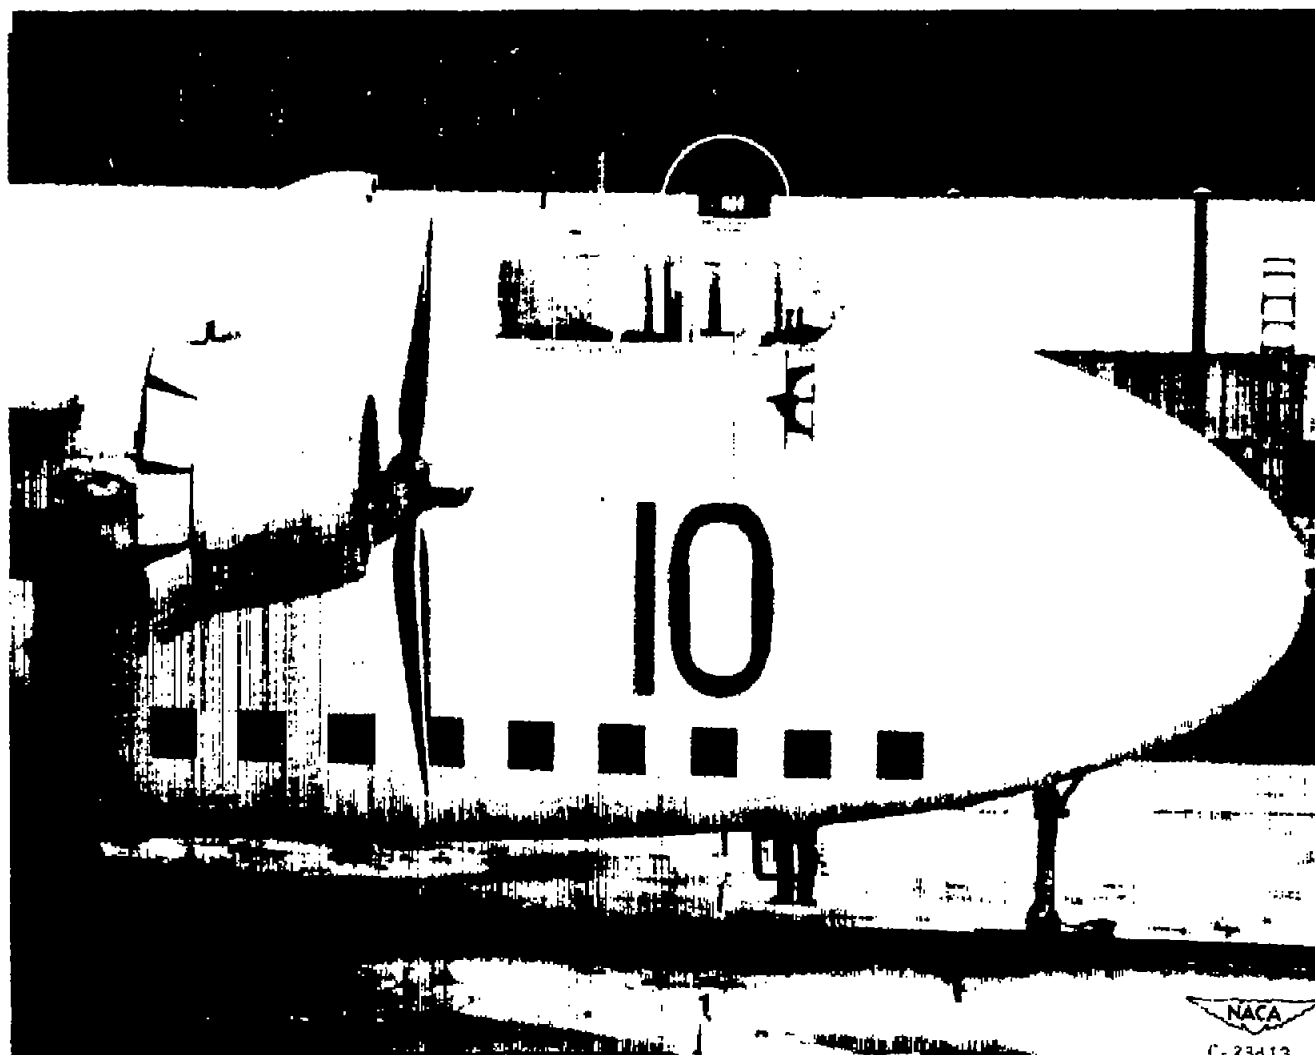
(a) On top of fuselage.

Figure 28. - Timing lights installed on C-82 airplane.

The lights were so located on the airplane that each of the cameras around the crash area would photograph at least one set of lights regardless of the position of the airplane in the crash area. One set of lights was installed on top of the fuselage above the cockpit as shown in figure 28(a); one set was installed on each wing tip as shown in figure 28(b); and another set was installed on the outboard side of each vertical stabilizer (fig. 28(c)). All the lights were connected to a clock-timer mechanism located in the insulated instrument box. This timer also controlled an indicating light so installed on the instrument panel in the fireproof instrument box that synchronization of the external light with the instrument panel light was obtained. In this way, the panel instrument readings could be related to the motion-picture records obtained by the cameras stationed around the crash area.

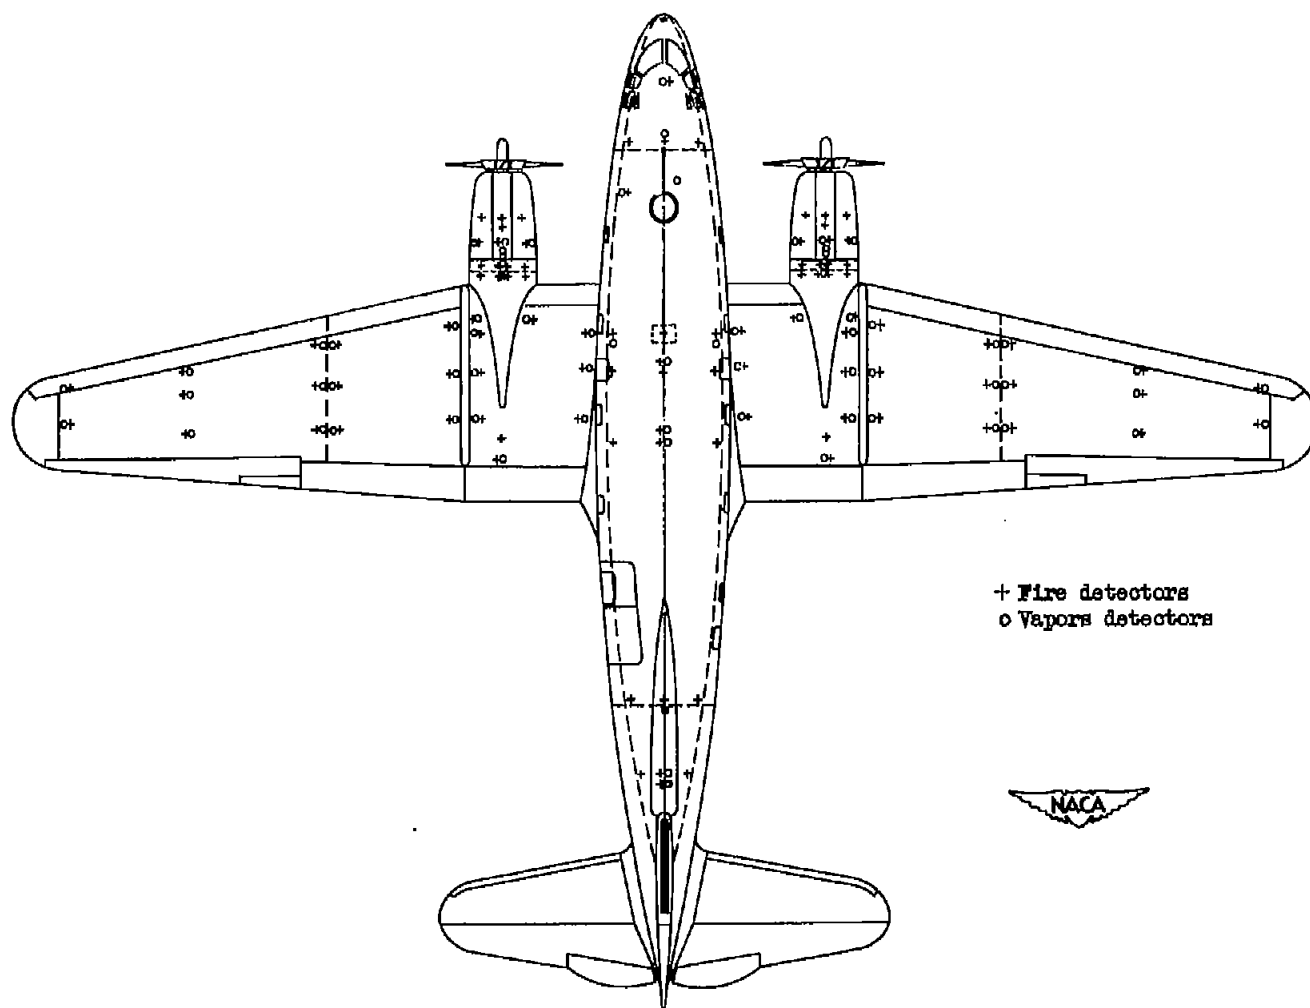
Figure 29. - Location of fire and vapor detectors installed in C-46 airplanes.

Fire detectors. - Thermocouples were used to detect the origin and spread of flame throughout the aircraft structure. A typical thermocouple installation of a completely instrumented airplane is shown schematically in figure 29; coverage of the nacelles, wings, and fuselage was obtained by use of 102 thermocouples. The greatest number of thermocouples were located in the nacelles near the exhaust-disposal system where the fire was likely to originate. Each thermocouple was connected to a meter on the instrument-box panel.

The locations of the vapor detectors (fig. 29) were chosen as the most likely paths that combustible vapors may follow throughout the structure of the aircraft. Each detector consisted of a 24-volt army-type C-1 booster coil sealed in a black iron body, a copper mesh screen, and two thermocouples. The booster coil supplied a spark which was totally enclosed in the copper screen that acted as a Davy safety shield. As a combustible vapor passes through this screen and comes in contact with the spark, burning occurs inside the screen. A thermocouple installed inside the screen was used to indicate when ignition of the combustible mixture within the screen occurred. An additional thermocouple, located outside the screen, was connected in series with the thermocouple inside the screen and indicated passage of a flame front. With this arrangement, a positive reading would indicate a combustible vapor; a negative reading, fire; and an ambient-temperature rise would not change the reading.

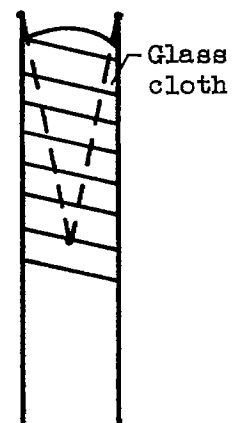
(b) Wrapped.

Figure 30. - Construction of thermopiles.

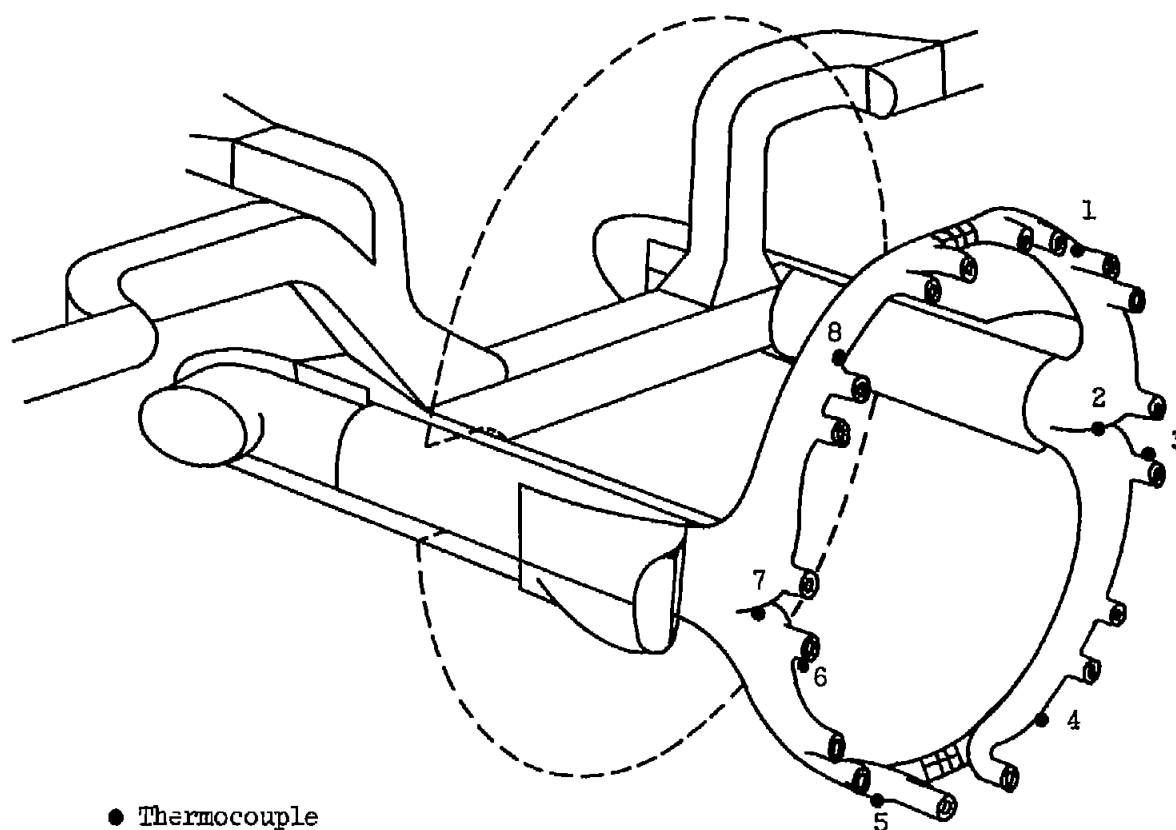
● Thermocouple
location

Figure 34. - Left-engine exhaust-stack thermocouple locations on C-82 airplane.

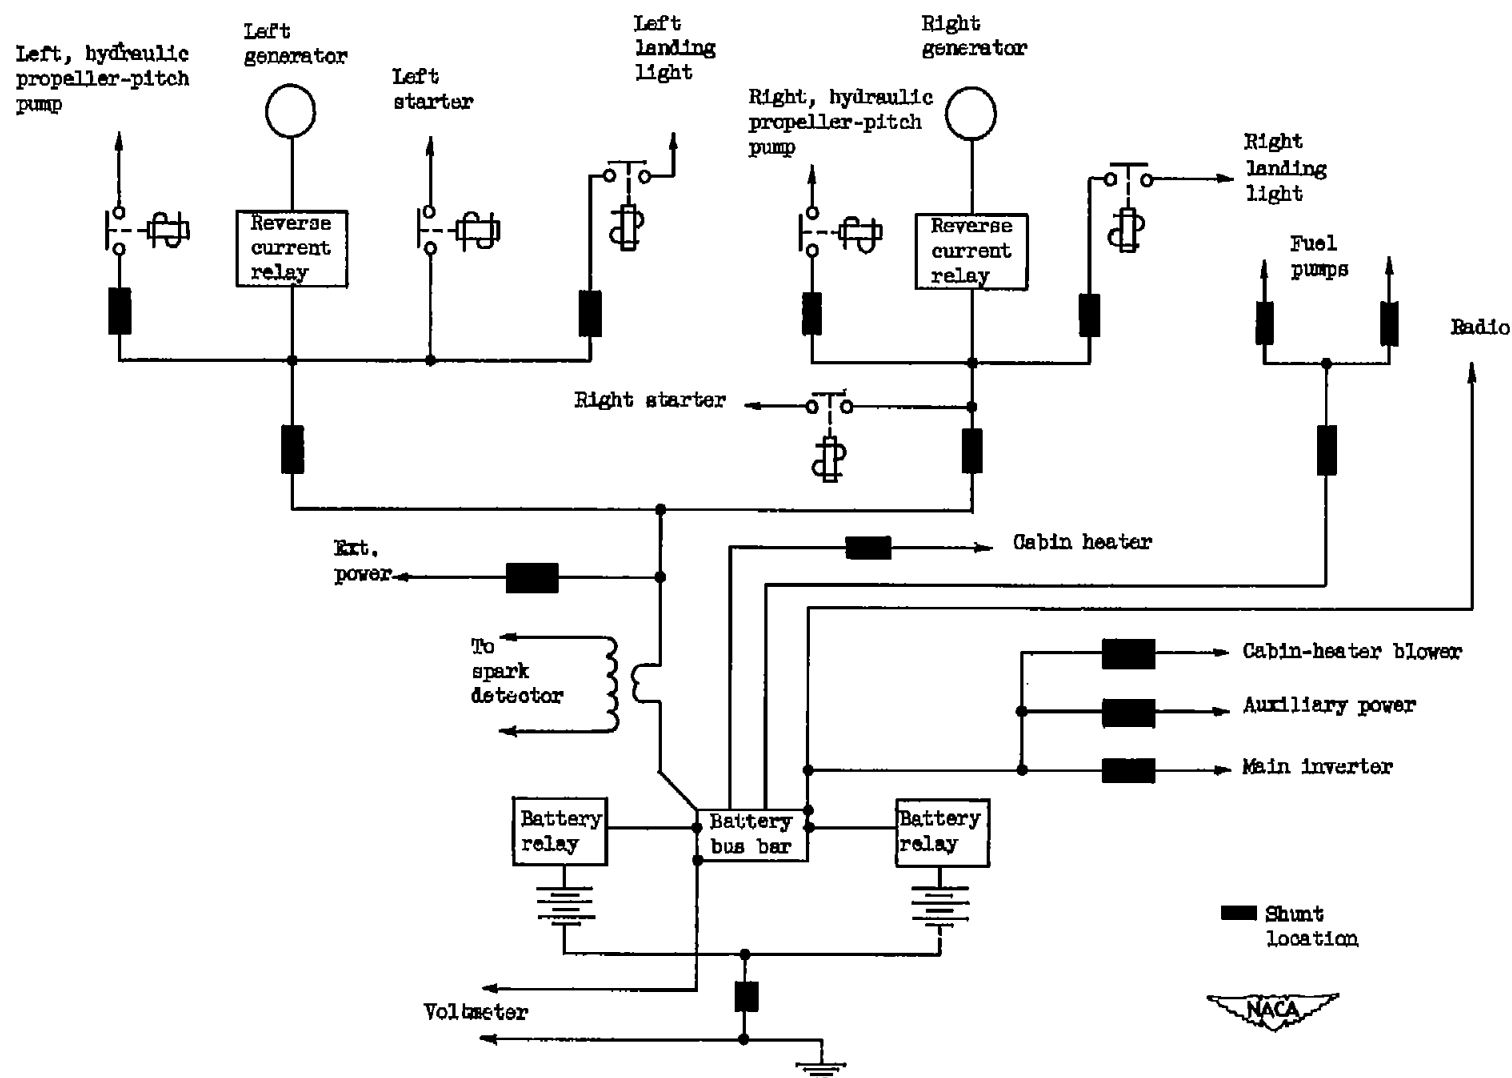
Figure 35. - Shunt locations in electric system of C-16 airplane for third crash.

Detection of electric-system failures. - In order to detect electric-system failures that could provide ignition sources, shunted ammeters were installed in the electric system of the test airplanes. All ammeters registered from 0 to 300 amperes. Shunts used in this installation provided a 50-millivolt voltage drop, which corresponded to a short circuit when 300-amperes flowed. These shunts were placed in the electric lines at various locations throughout the airplane (fig. 35) and connected to ammeters installed on the panel in the instrument box by asbestos covered number 14-gage solid-nickel wire. Abnormally high currents caused by arcing of a broken power line were measured by the shunts and the ammeters.

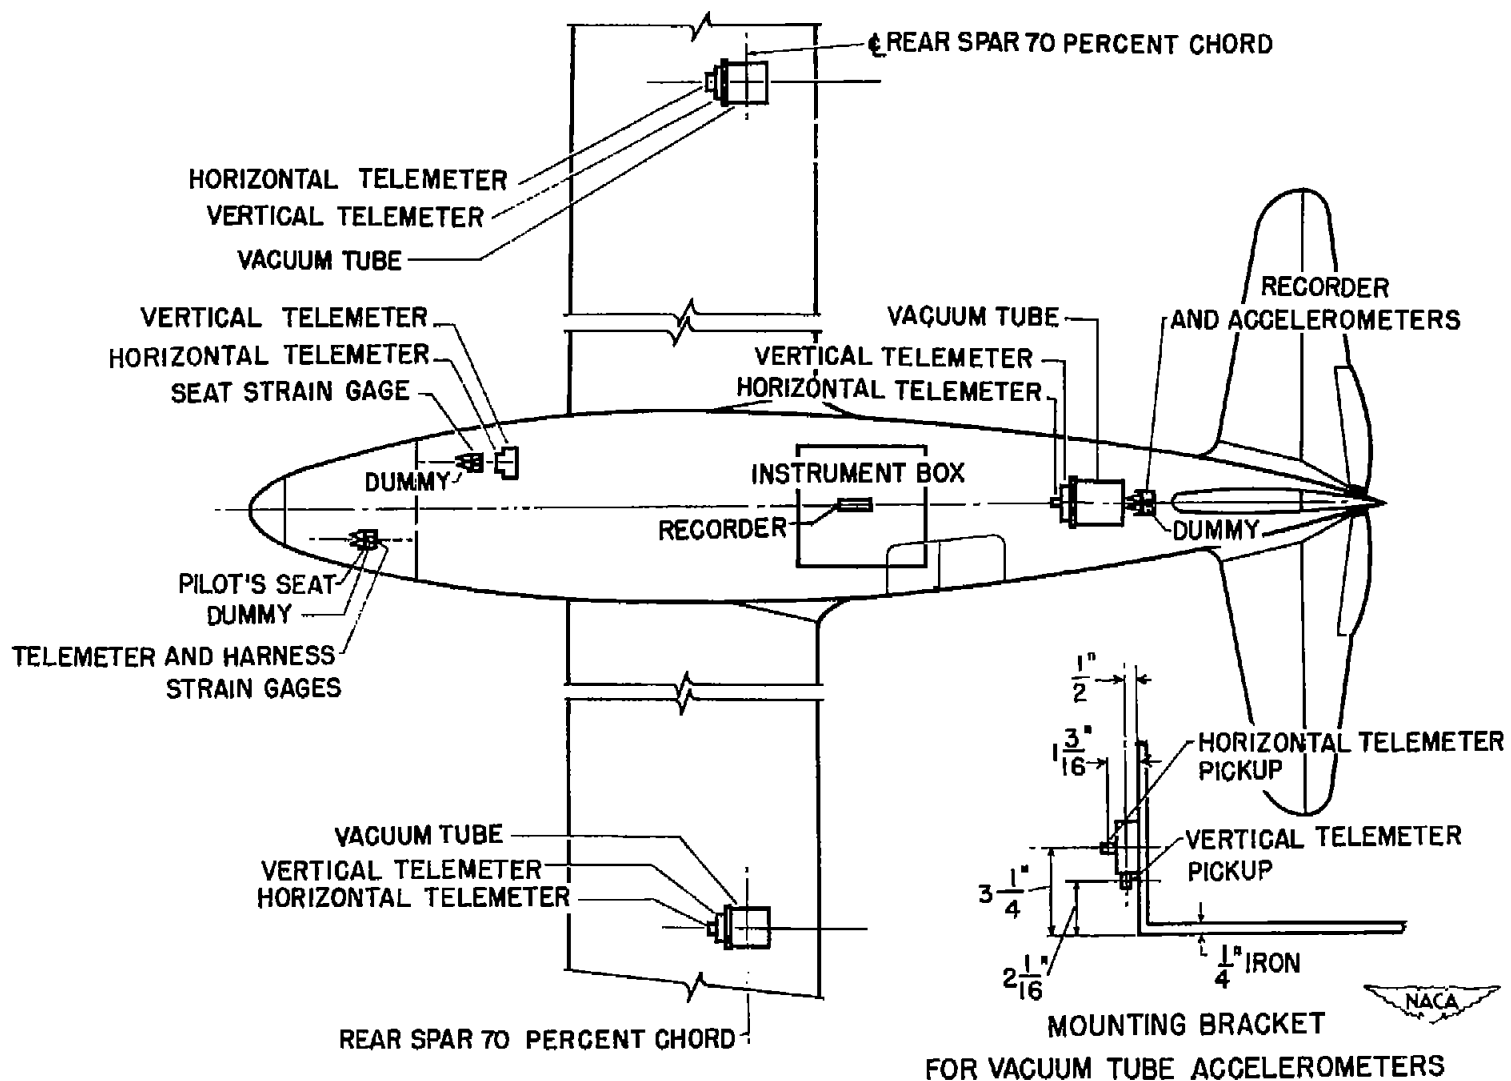
Figure 36. - Recorder, accelerometer-pickup, and strain-gage locations in C-46 airplane.

Variable-inductance accelerometer-pickups that recorded through a telemetering system were installed in the aircraft because investigations at the NACA Langley laboratory have indicated that this system was one having low zero shift and high accuracy. Two telemetering transmitters, operating on 134 and 150 megacycle frequencies, were installed on the passenger compartment floor forward of the instrument box. The transmitting antennas were mounted at about 45° angles on the sides of the fuselage 2 feet below the top. Two pickups for measuring structural accelerations were installed in each of four locations in the aircraft as shown in figure 36. These pickups were mounted on angle brackets and aligned in the horizontal and vertical planes with the aircraft in flight attitude. Two pickups were mounted on brackets on the left- and right-wing lifting attachment points for rigidity (fig. 36). These pickups indicated wing accelerations, which could be correlated with accelerations determined with the vacuum tubes. The other two pair were located close to the dummies in the fuselage of the aircraft (fig. 36) so that harness strain-gage data could be related to the telemetered accelerometer data.

from 0.015-0.010-inch diameter. This vacuum tube, used as a transducer, was a dual diode tube which is essentially a pair of rectifiers connected in series and having a common cathode. As accelerating forces acted on the tube, the plates moved a distance proportional to the acceleration force. One plate moved toward the cathode and the other away from it thus the effective resistance of one-half of the tube increased and the other decreased as acceleration was applied. This tube was so connected that the two halves were two adjacent legs of a Wheatstone bridge. The electric output was applied directly to a rotating-mirror-type recording galvanometer. The data were obtained on photographic film. The tubes were located in the fuselage and wings of the airplane as shown in figure 36. The boxes in which the pickup tubes were mounted were made of 1/32-inch steel and secured with 1/16-inch by 1/2-inch steel straps to the bracket shown in figure 36.

In the third system, unbonded strain-gage accelerometers were used in conjunction with two 6-channel pilot-seat-ejection recorders. The unbonded strain-gage accelerometers consisted of a thin metal cantilever beam attached to an aluminum frame which was bolted to the point at which accelerations were to be measured. Attached to this cantilever were insulated posts between which thin resistance wires were stretched. As an accelerating force was applied to the system the cantilever beam bent and the wires on one side were stretched, whereas those on the other side were relaxed. Resistance increased in the stretched wire and decreased in the relaxed wire. Both changes were proportional to the amount of bending in the cantilever beam which was proportional to the accelerating force. The wires were connected in a bridge circuit and energized by a constant voltage from the pilot-seat-ejection recorder. The bridge output voltage was proportional to the bridge unbalance voltage which was proportional to the resistance changes previously mentioned. Thus, a voltage proportional to the accelerating force was obtained. The bridge unbalance voltage was detected and used to shift the frequency of a 3500-cycle-per-second oscillator the output of which was recorded on magnetic iron-oxide-coated paper tape. The locations of the recorders and accelerometers are shown in figure 36.

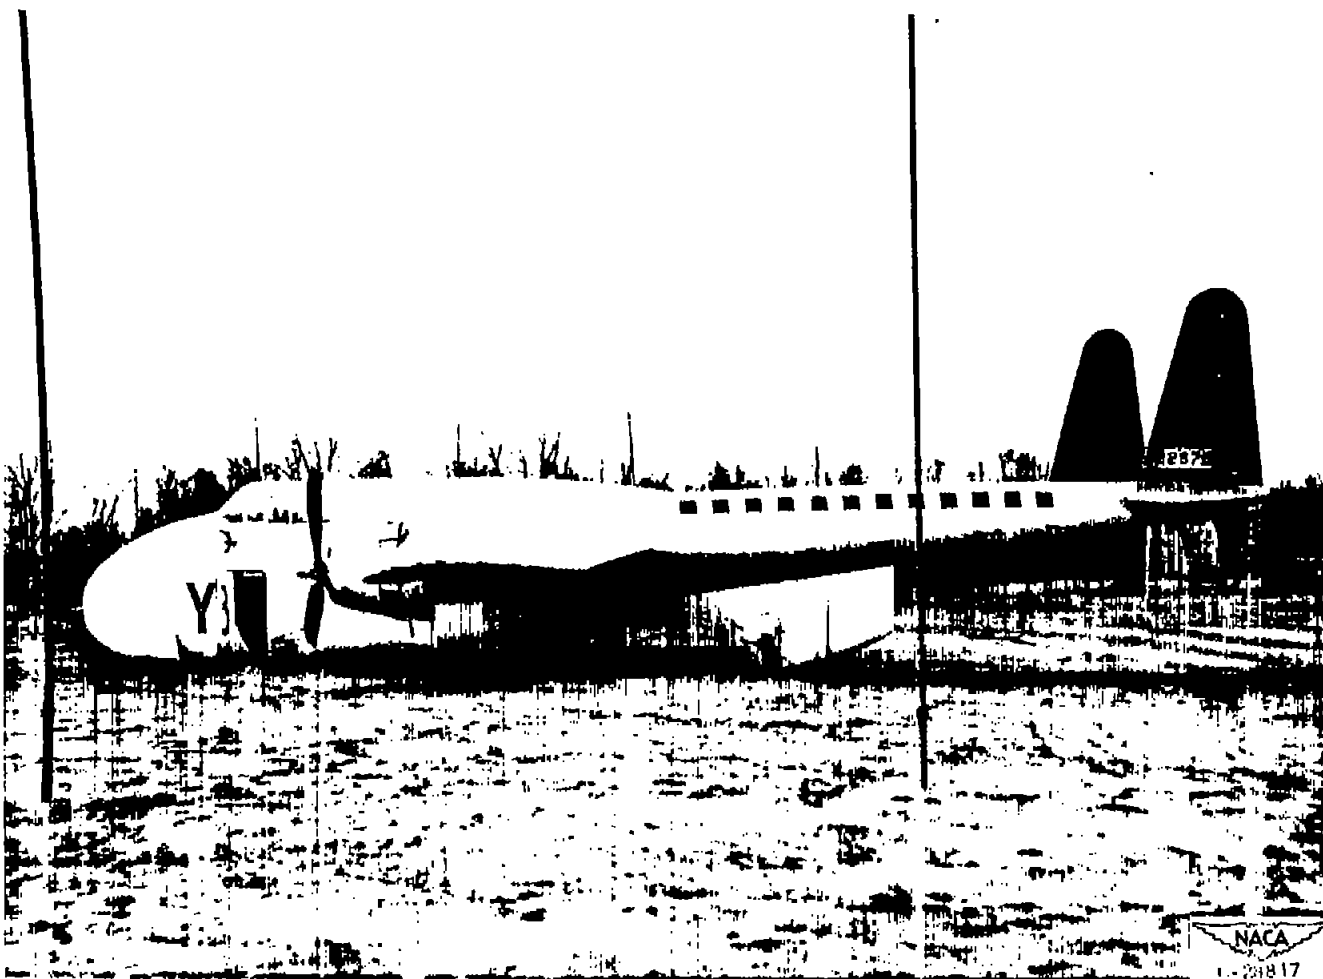
Figure 39. - Black squares painted on side of C-82 airplane and stationary poles in crash area for determining velocity.

The velocity of the airplane through the crash and subsequent slide was determined photographically. This system was based on poles located between the airplane and the motion picture cameras and 1-foot black marks painted on each side of fuselage and tail boom of the airplane at 1-foot intervals. A black mark painted on the side of the airplane lined up with one of the poles in the crash area as shown in figure 39. It was thus possible to obtain an approximate measure of the airplane speed from the motion pictures by making a frame by frame study of the position of the index marks on the airplane relative to the stationary poles.

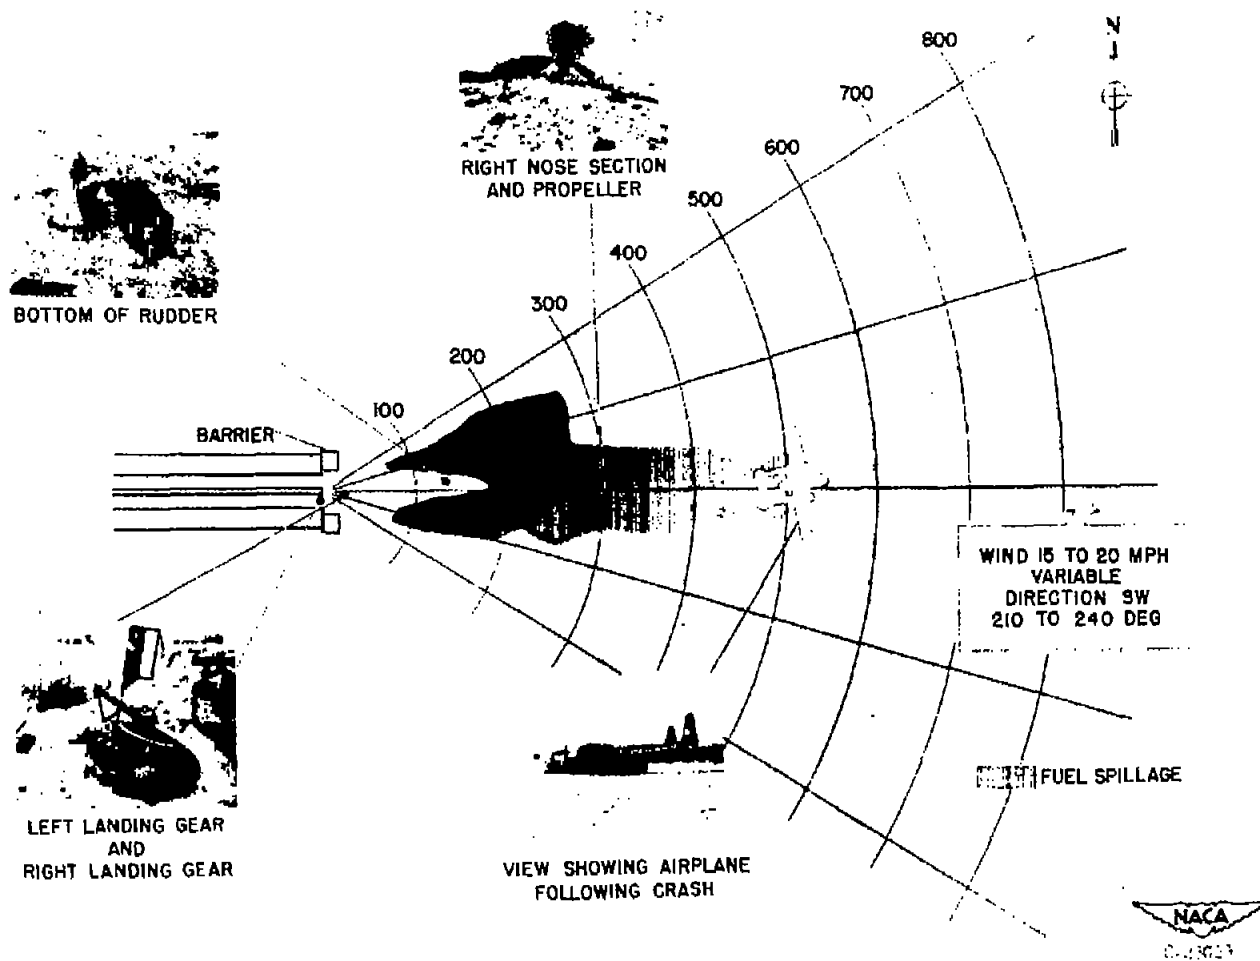
Figure 40. - Distribution of wreckage of C-82 airplane following simulated take-off accident. Test No. Y-4.

The distribution of wreckage was plotted with a plane table and alidade. The following portions of the airplane wreckage and the terrain were identified, recorded, and photographed such as: (1) main landing gear, (2) engine and propellers, (3) sections of the wings, and (4) sliding path, location, and burned-out portion of the airplane. The information obtained by plotting and photographing the distribution of wreckage was transferred to a composite photograph an example of which is shown in figure 40.
